REP-# 168

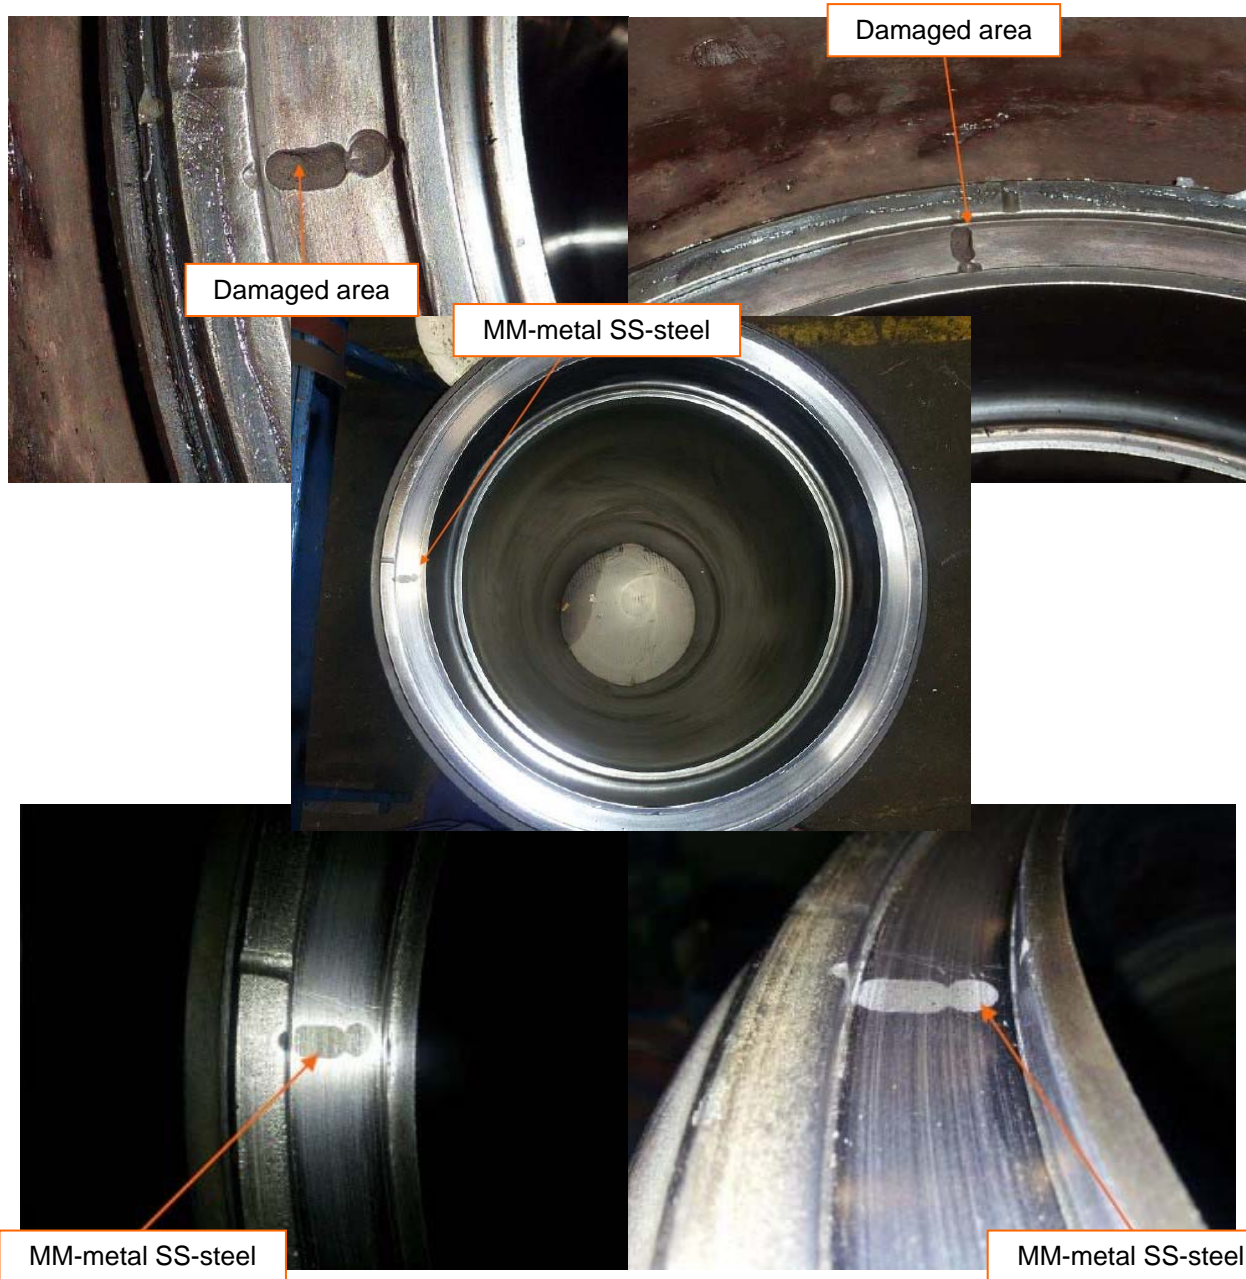
The cylinder liner of a tanker's diesel engine was damaged. The sealing surface to the cylinder head was drilled into by mistake. The material loss at the damaged area was equalized again by applying MM-metal SS-steel (pasty) with Hardener yellow (pasty). After curing this repair area received a surface-grinding. This way the repaired engine was put into operation very fast again. Due to the use of this PolymerMetal from MultiMetall the expensive supply of a new cylinder liner was not necessary which would have resulted in a more than 25-times higher repair cost.
